Analysis of Leakage Current Calculation Through Thermal Failure Voltage on 150/20 kV Transformers in GIS Simpang, Surabaya

Keywords: Gas Insulated Substation (GIS), Leakage Current, Thermal Failure Voltage

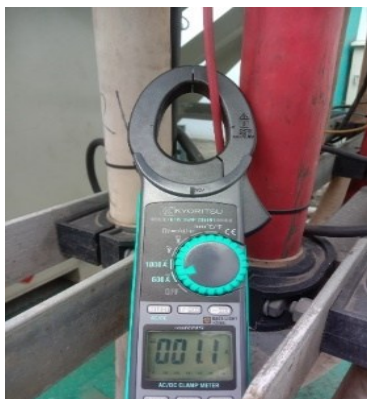
The total number of cables measured from the R phase, S phase and T phase is 9 cables from each core or core of each cable. Measurements are carried out using a clamp meter. In Figure 1 and Figure 2 is a picture of the clamp meter measuring tool used to detect leakage current.

Figure 1. Leakage Current Measurement with Clamp Meter [24]

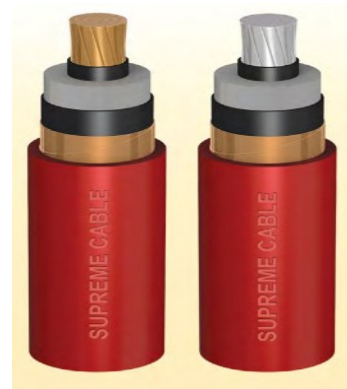
The cable used in GIS 150 kV Simpang is XLPE type cable. XLPE cable is the best cable for transmission and distribution lines because of its excellent electrical and physical properties. XLPE itself is formed from polyethylene polymer which undergoes a cross-linking process. The type of cable measured in the leakage current measurement process is XLPE cable or Supreme 20 kV cable. The cables used are the N2XSY Cable, which is a copper core cable with XLPE insulation and a PVC cover sheath, and the NA2XSY Cable, which is a single aluminum core cable with XLPE insulation and a PVC outer sheath. More complete specifications regarding the type of cable used for leakage current measurements are explained in Table 1.

Figure 3. N2XSY or NA2XSY Wire [25]

The conductor wire used is copper or aluminum, and the type of conductor is determined by considering several things, namely current capability and price. The type of conductor that is often used on the secondary side of 150/20 kV transformers is XLPE, which is installed via underground channels to the 20 kV cubicle.

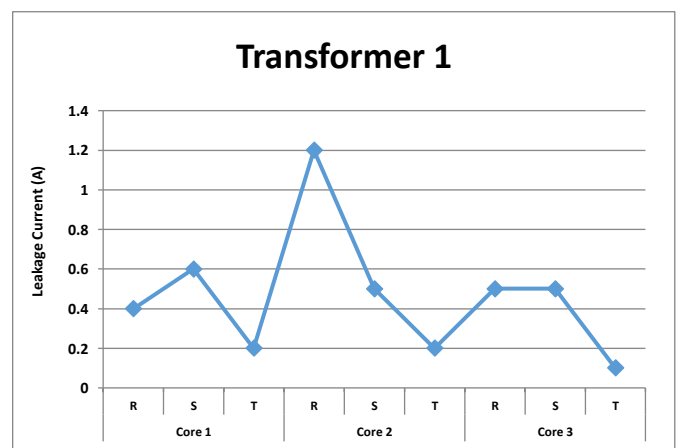
Figure 4. Leakage Current on Transformer 1

The data table contains comparison results between calculation data and leakage current measurement results using a clamp meter. The data included in this table is data from the second week, which compares the results of measurements and calculations from transformer bay 1 and transformer bay 2. Table 6 shows a comparison of the calculation and measurement results related to wire temperature, thermal breakdown voltage, leakage current, and measurement current. At higher wire temperatures (e.g., 39.6°C), the leakage current tends to be slightly higher, while at lower temperatures (e.g., 35.5°C), the leakage current decreases. Next, these data will be included and graphed to find out the comparison results from the second week. This comparison graph consists of two graphs that are analyzed, namely the comparison graph of transformer bay 1 and transformer bay 2. The following is an analysis of the comparison graph between the results of measurements and calculations from transformer bay 1 and transformer 2 in the second week:

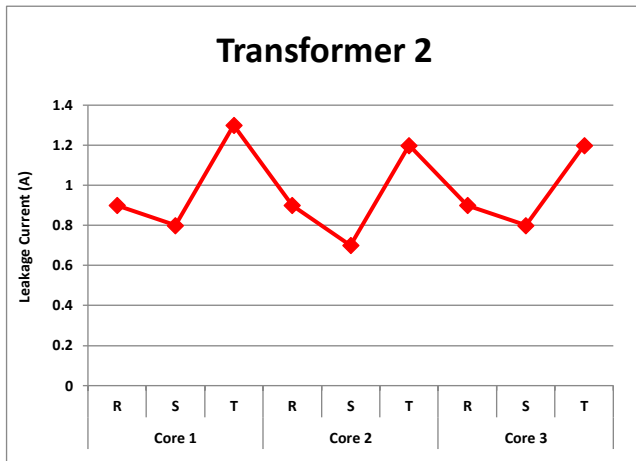
Figure 5. Leakage Current on Transformer 2
